Chicora Foundation, Inc.
PO Box 8664, Columbia, SC 29202

March 2009

Monumental Issues

Treatments Continue in Mobile's Magnolia Cemetery

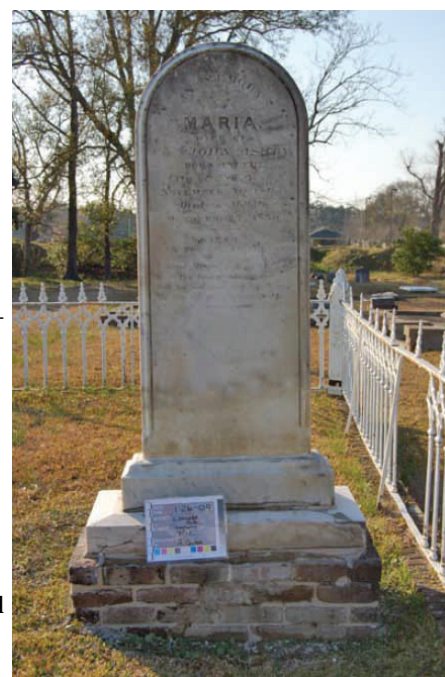
After Treatment

The result was not simply a repaired stone, but also one that looks dramatically different. The elevation of the monument today reflects the original three-dimensional intentions of the original craftsmen.

Using a tripod rated at 1-ton, the die was lifted and reset on the base. The stainless steel pins were attached using what conservators call a hi-mod (i.e., high strength) moisture insensitive structural epoxy.

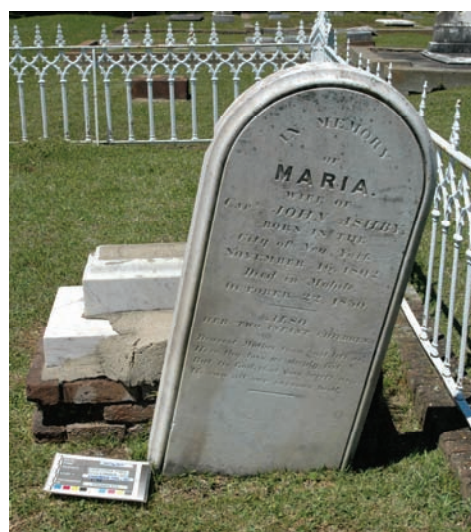
Before Treatment

One interesting monument, of Maria Ashby, was a very large and heavy tab in socket stone. The tab and socket were both damaged and the socket had been filled with Portland cement. The die had fallen and

was sunk into the soft Mobile soil nearly a foot. To complicate matters, the stone had been placed on a brick foundation that raised the stone an additional foot and half. Much of this pier was deteriorating with mortar eroded from joints and bricks either loose or entirely missing.

Treatment required that the Portland cement be partially removed, so that it would not be visible after the repair. It also required

support the massive stone.

that the brick support be extensively repaired. It was re-pointed using a 1:2 mix of NHL 3.5 and sand.

The die was removed from the soil and drilled for the insertion of two 5/8-inch 316 stainless steel rods to connect the die to the socket and its base. The rods needed to go through both in order to adequately

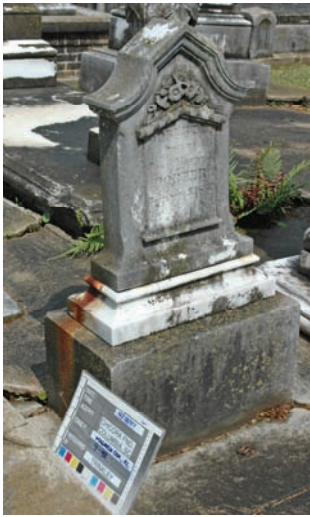
Before Treatment—
note the corrosion
staining on the left
side.

The original stone mason had set the marble die on base using two ferrous pins to connect the die with base. Over time these pins had begun to corrode. This process is known as iron jacking and the iron begins to expand with the corrosion products taking up more and more room. Eventually the corroding pins will crack and split the stone. The before treatment photo clearly shows

the corrosion staining down the left side of the monument.

Treatment involved taking this monument apart, using a diamond core drill to remove the old, corroded pins, and replacing them with 316 stainless steel pins.

The monument could then be reset, using a 1:3 mix of NHL 3.5 and stone dust. The stone was cleaned using D/2 and the corrosion stains were removed using a poultice to draw the discoloration out of the marble.
